## TIP method used to rehabilitate pipe liners

### Project data:

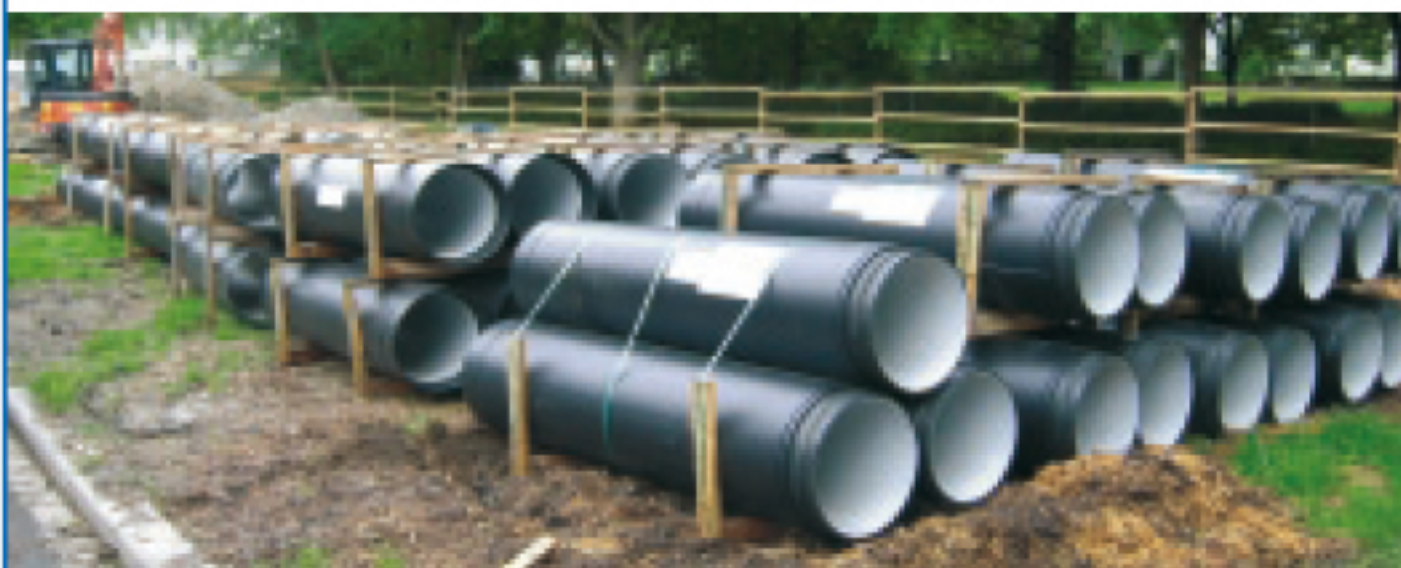
The rehabilitation of rehabilitation work – this is an operation whose cause can be attributed among other things to the selection of incorrect material and process. The (EP-based) pipe liner installed originally gradually collapsed in several places under the constant ingress of water that was up to 90°C in temperature. After milling out the liner inspection revealed further damage such as cracks of all types, missing parts of walls, offsets etc., indicating that the TIP method was the most sensible measure to use here. Here the new pipes, which have an OD that is only slightly smaller than that of the DN 500 old pipe to be rehabilitated, are inserted

into the old pipe behind a calibrating guide sleeve tight-in-pipe, i.e. with minimal annular gap. The connecting sewers are precisely measured before inserting the pipe, then exposed again using a milling robot, and (in this case) finally reconnected using the Janßen connection method. The egeplast SL PP-B modules made of polypropylene, OD 475 x 26.9, were installed with stable tension in one day. A collector rehabilitated using the TIP method can be estimated to have almost the same service life as a newly built one. This is a fact that should always be taken into consideration before selecting and when assessing rehabilitation measures.
